TSB - FW01

Models applicable > Ford > New Holland / John Deere / Case

CLUTCH PLATE REPLACEMENT (Upgraded discs)

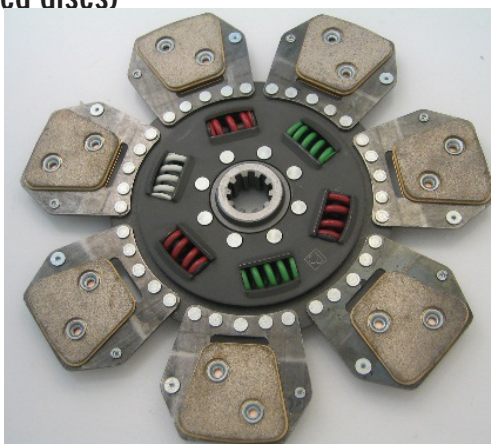
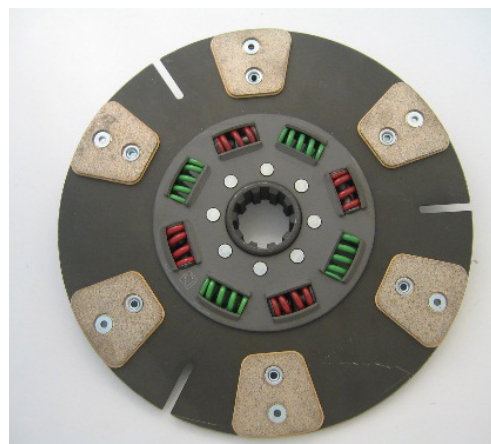
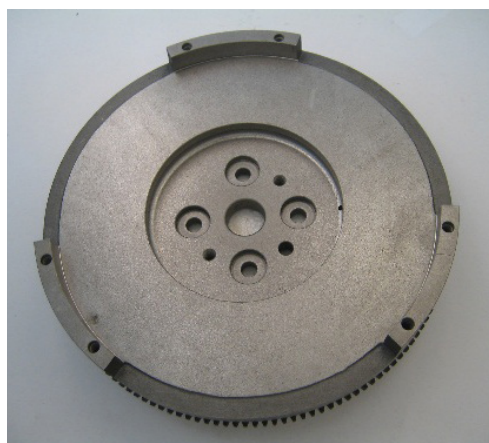
CHECK HUB CLEARANCE

Some manufacturer's discs are rationalized or upgraded for various reasons.

This often incorporates a larger hub design and may therefore require the inner flywheel rebate to be machined to a larger diameter to allow correct hub clearance of the plate.

Failure to check the above may result in release problems, clutch shudder and premature clutch disc failure.

The diameter should be approximately 2mm larger than the outer segment rivet or the outer hub spring cage as shown above.
