## TSB - FW03

Models applicable > Fiat > 160-90,180-90,1580,1880  
Massey > 3680,3690

Details > when fitted with 310mm twin plate cover assembly  
Ag Clutch Part Numbers > 631 3105 FI and 631 3101 MF

### FLYWHEEL MACHINING and CLUTCH KIT REPLACEMENT

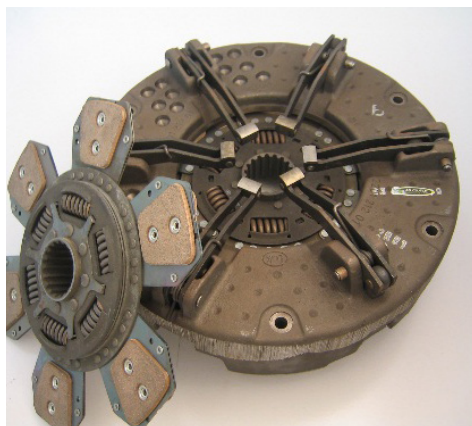
631 3105 FI

In the above applications the cover is designed to release the clutch plates simultaneously, allowing even torque transfer and consistent engagement.

Severe flywheel wear is quite common due to the use of ceramic discs - if the flywheel is not restored to original condition this can simulate a worn flywheel side disc, therefore changing the lever height.

This causes the flywheel side disc to release prematurely resulting in rapid disc wear and ultimately cover assembly and clutch failure.

Ag Clutch recommends complete clutch kit replacement and correct restoration or renewal of the flywheel.

The flywheel step must be restored to the original FLAT condition (cover OD locating spigot = 362mm diameter)
