TSB - MF05

Models applicable > Massey MF298,398,399,575,698,699
MF4245,4255,4270

Details > with 330mm (Split > Torque) cover assembly
FLYWHEEL RESTORATION / COVER COMPATIBILITY
Ag Clutch Part Numbers >

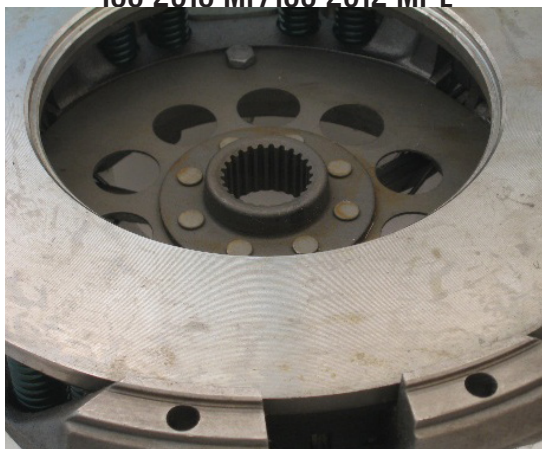
133 2513 MF/133 2512 MF-L

(with locating lip)

WITH LOCATING LIP > The cover has an internal locating spigot which locates in a rebate of the flywheel.

When fitting Part no > 130 2512 MF-L or 133 2513 MF the flywheel must be restored to original whenever new clutch is fitted. The outer rebate must be restored to no less than 3mm in depth to establish the correct cover location.

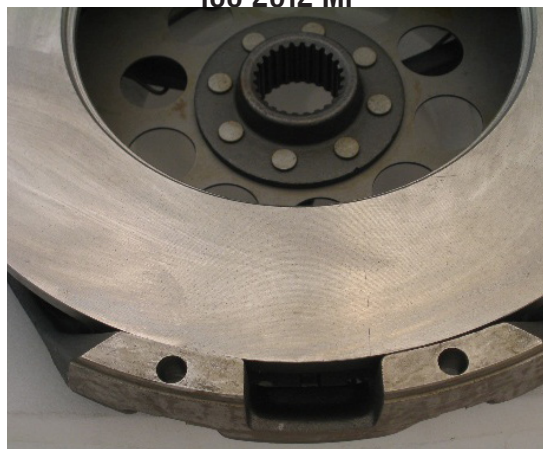
133 2512 MF

(no cover locating lip)

NO LOCATING LIP > The cover has an external locating spigot which locates against the outer wall of the flywheel.

When fitting Part no > 130 2512 MF the flywheel must be restored to original whenever new clutch is fitted. The outer wall spigot must remain at approximately 3mm in height to establish the correct cover location.
